**UNITED STATES DISTRICT COURT
SOUTHERN DISTRICT OF OHIO
WESTERN DIVISION**

CASE NO. 1:17-cv-00695

AFFIDAVIT OF JEREMY PORTER,
PMP

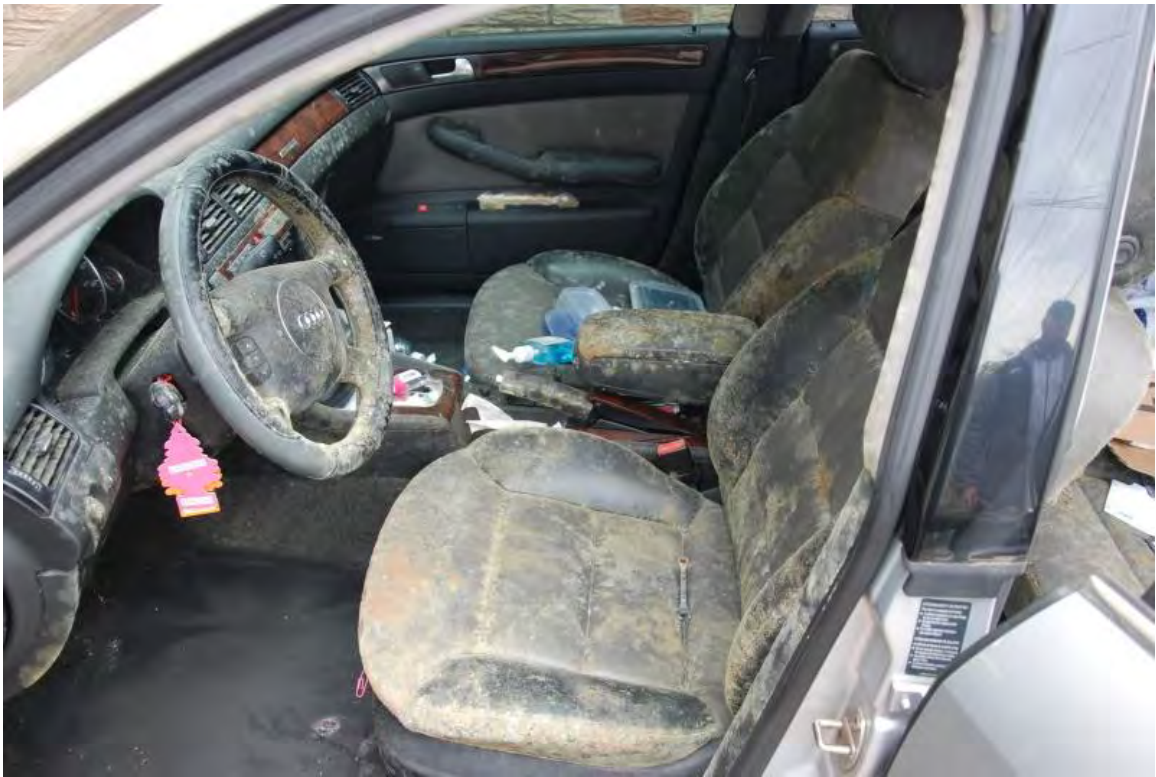
Photo is not of the subject vehicle.

Example of vehicular mold growth. The mold is growing on the organic leather of the vehicle, notice the carpet is not moldy as it is not a food source for the mold.

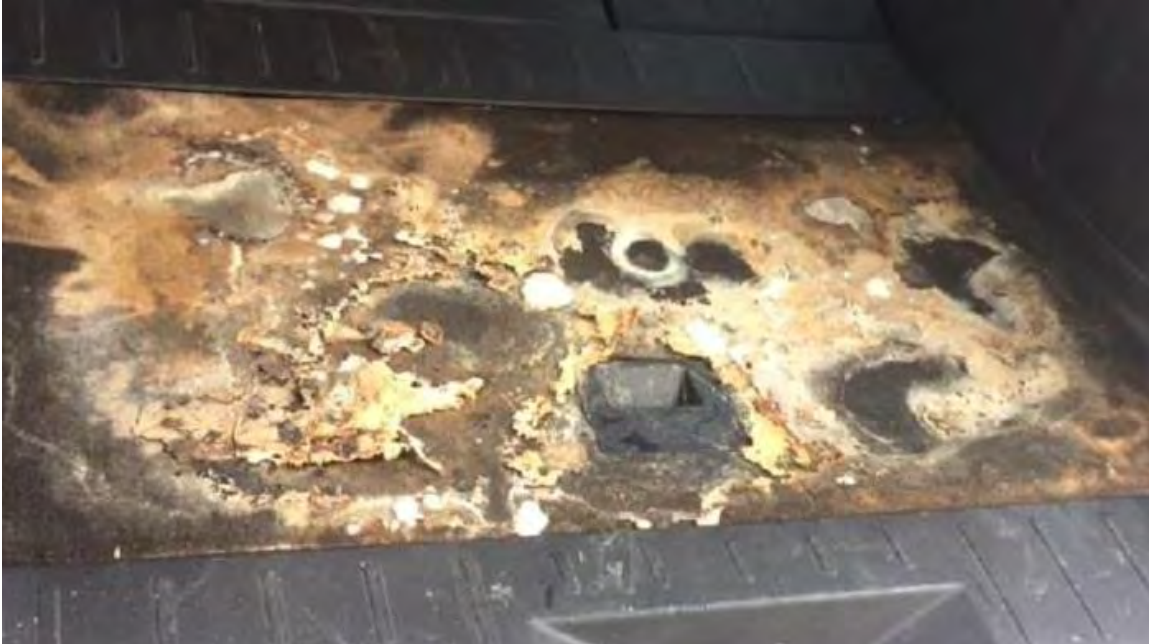
Photo is not of the subject vehicle.

Example of vehicular mold and bacterial growth. In this case milk was spilled which provided both the food and moisture source required over a long period of time.

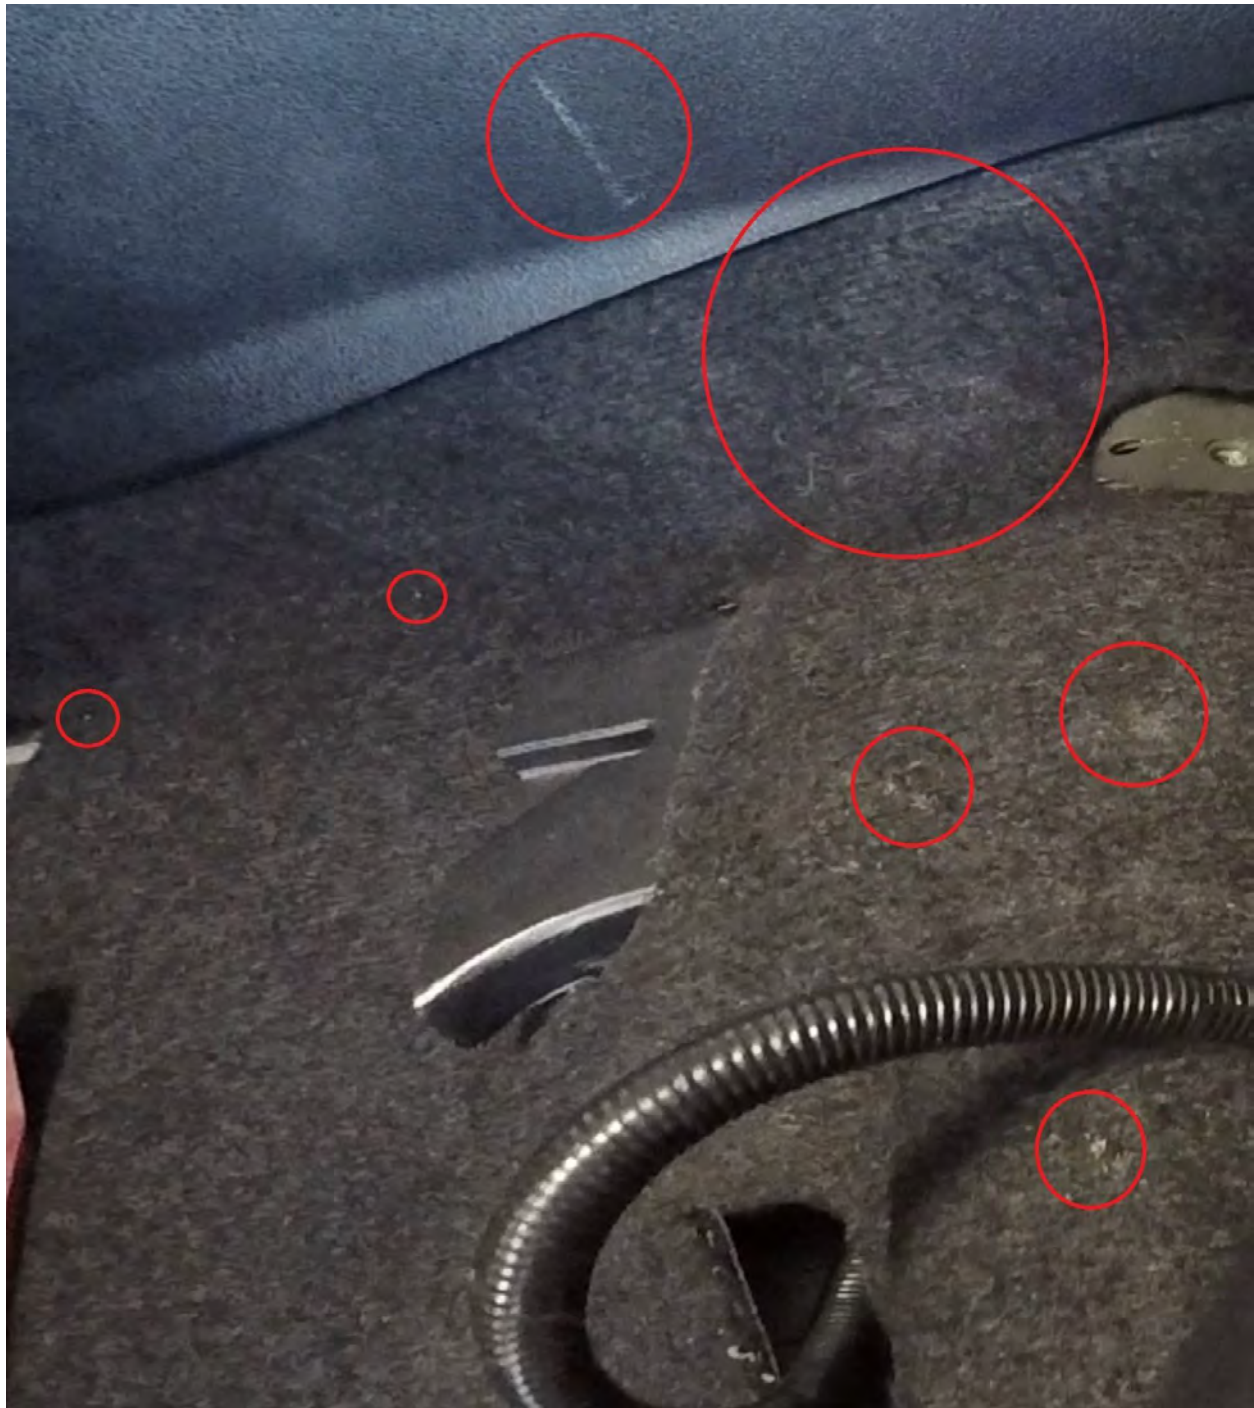
Photo of evidence of spilled food and beverages as well as particles of dust. The beverage drip on the top of the photo is directly below the cup holder and in close proximity to the endotoxin sampling location. This spill would normally be hidden when the seat is installed in the vehicle.

Assuming that this endotoxin reservoir did exist as the time of inspection and sampling, it is very unlikely that this particular contamination existed at the time the Mrs. Beckemeyer was using the vehicle. The inspection and testing was conducted over 21 months after vehicle use was discontinued by the Mrs. Beckemeyer. The record indicates the vehicle was detailed (thoroughly cleaned) on at least 3 occasions, July 9, 2016, prior to sale at auction on September 30, 2016 and in preparation for sale by Bob Rohrman Subaru.

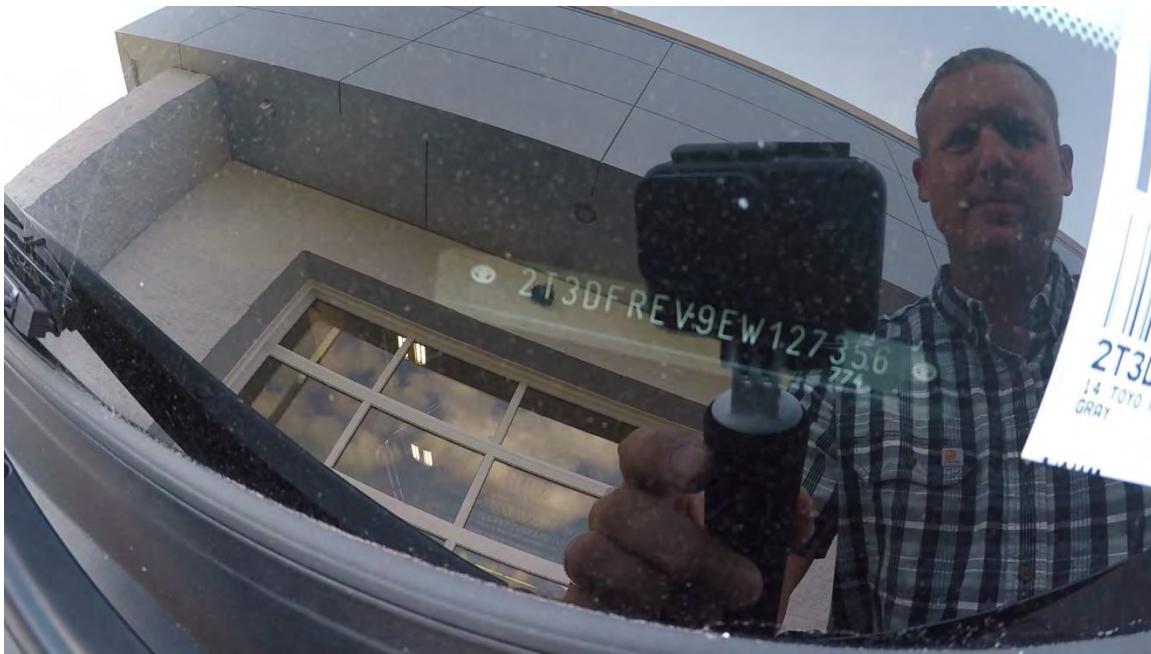
Vehicle VIN number checked and verified. This is the subject vehicle.

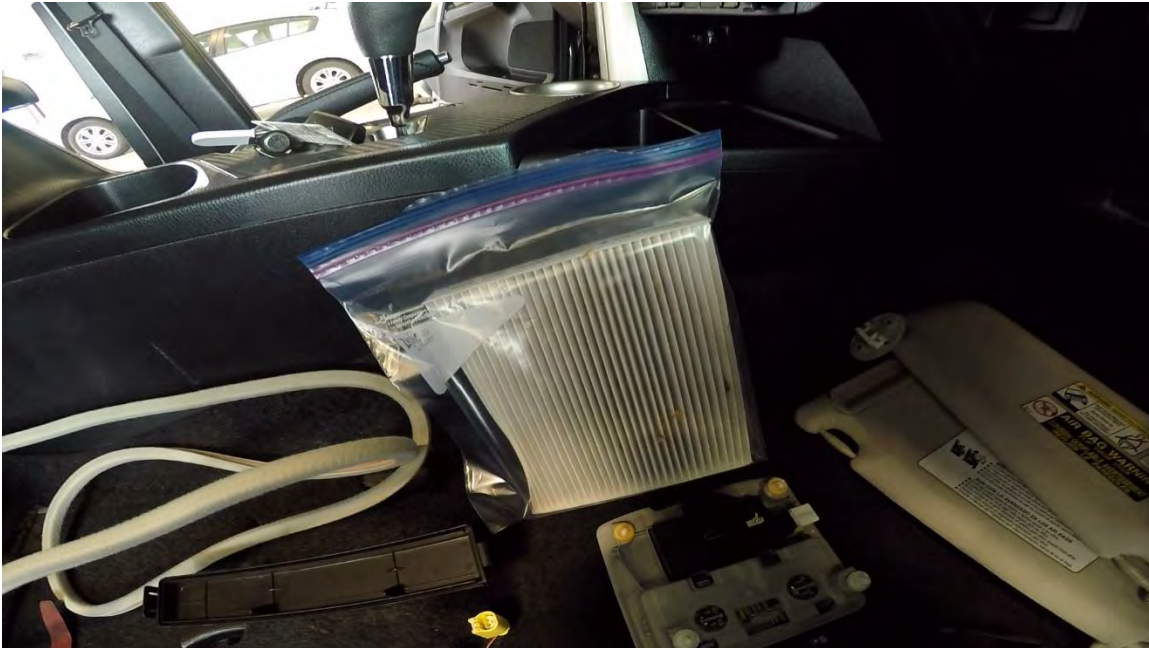
Vehicle HVAC System Filter removed for analytical testing

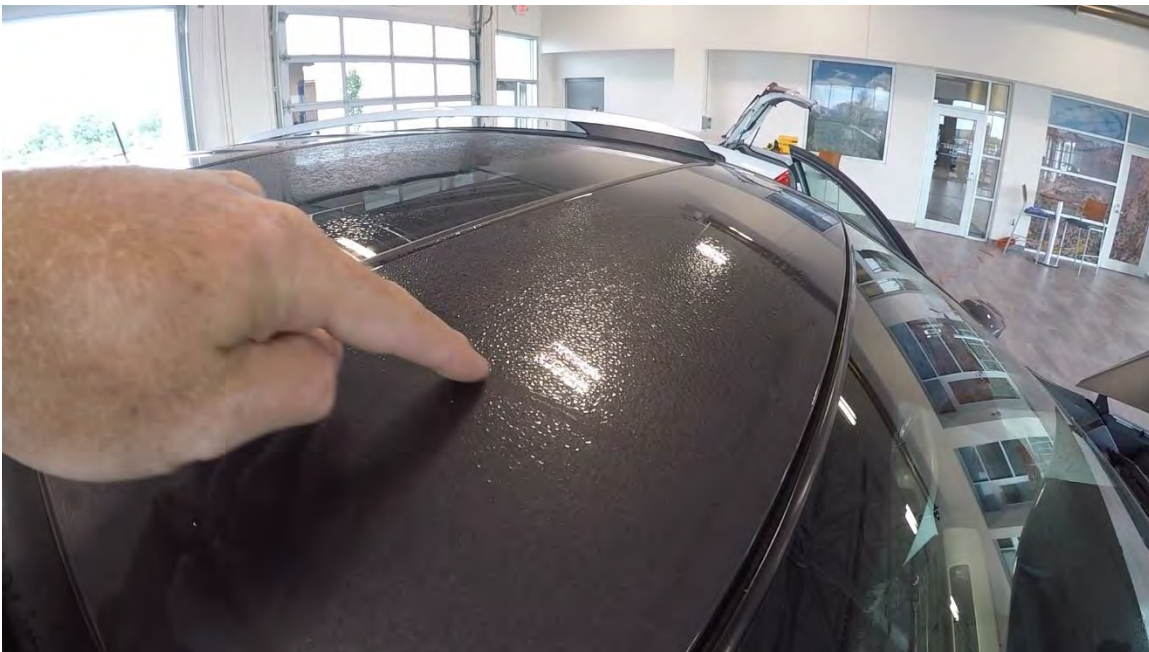
Condensation in the exterior of the vehicle following A/C use by Mrs. Beckemeyer's expert
